Case Study: CH-1960

REFINERY REDUCES OVERHEAD CORROSION THROUGH CONTINUOUS ANALYSIS AND ONLINE CONTROL

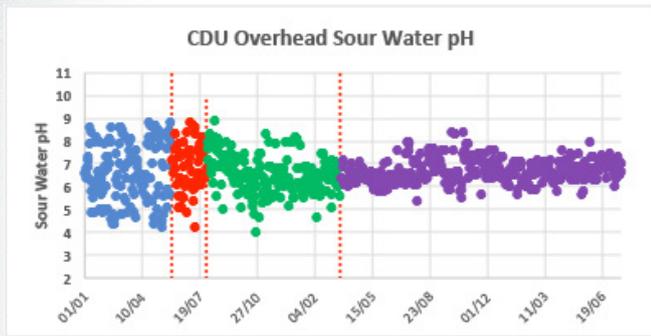
Figure 1: CDU Overhead Sour Water pH

The main objective of installing the 3DTCOS analyser was to significantly improve the pH control of the overhead sour water and consequently reduce the corrosion rates in the crude unit overhead exchangers. Figure 1 shows the daily laboratory boot water pH result before and after commissioning the 3DTCOS analyser and placing it in control mode. It is clear from this graph that since the 3DTCOS analyser was placed in control and the neutralizer dosing was automated and the variability of the overhead sour water pH has significantly reduced.

std dev	AVERAGE	UCL	LCL
Pre-3DTCOS	0.83	6.57	7.40	5.74
3DTCOS Monitoring Only	1.03	6.92	7.95	5.88
3DTCOS Control (1)	0.81	6.56	7.37	5.74
3DTCOS Control (2)	0.51	6.68	7.19	6.17

As a result of this trouble shooting and field modifications, the 3DTCOS unit can operate reliably as designed with only weekly routine maintenance. These improvements have allowed the refiner to gain confidence in the unit. Following commissioning these modifications to the sample conditioning system and the 3DTCOS analyser, the pH control and crude unit overhead corrosion has significantly improved, as can be seen in figures 1 and 2.

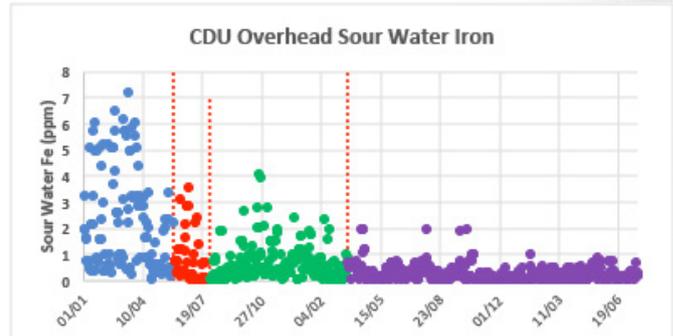
Figure 2: CDU Overhead Sour Water Iron Levels

Figure 2 shows the daily laboratory sour water iron result over the same time period, and from this, it is clear that the control of the corrosion rates has significantly improved as a result of the improved pH control.

std dev	AVERAGE
Pre-3DTCOS	1.11	0.85
3DTCOS Monitoring Only	0.90	0.76
3DTCOS Control (1)	0.66	0.66
3DTCOS Control (2)	0.30	0.30

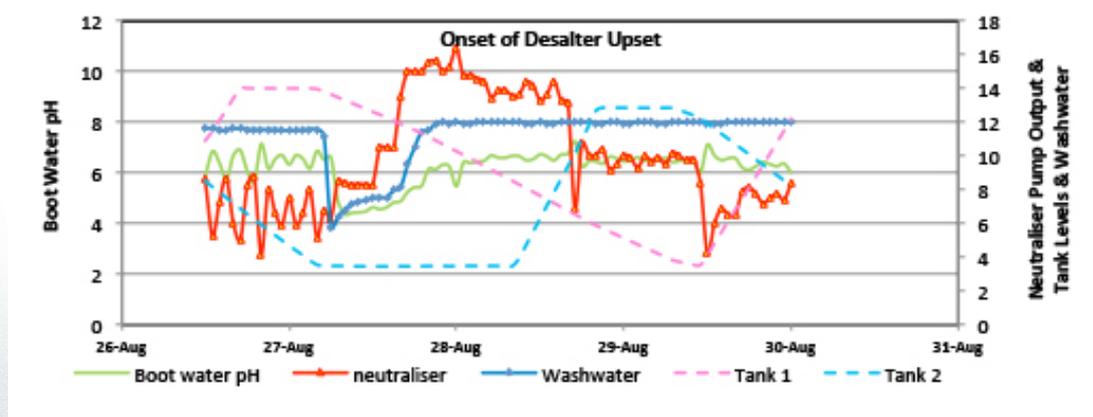
Figure 3: Impact of Wet Crude Tank

In one incident, the crude tank that was about to be brought online had been reported as containing a higher level of BS&W than the one currently feeding the crude unit. As this tank was brought online, desalter amps and interface levels rose sharply indicating a water slug had hit the desalter. To mitigate this event, operators increased demulsifier dosing and reduced desalter wash water rates. Shortly after, the overhead sour water pH dropped quickly from pH 6.5 to 4.5. In response to this reduction in pH, the 3DTCOS analyser significantly increased the neutralizer dose rate.

In this scenario, the real-time monitoring immediately highlighted the low pH of the sour water and the

potential for high rates of corrosion in the crude unit overheads. Without the presence of the 3DTCOS analyser, it is highly likely that this process upset would have gone undetected leading low pH conditions for a prolonged period, as any corrective action would only have taken place after the daily boot water sample was taken. This real-time analysis allowed from the 3DTCOS analyser allowed corrective action to be initiated quickly thus minimizing the duration of the corrosion event. Furthermore, once the unit had stabilized and the target pH was achieved, the unit optimized the neutralizer dose rate accordingly.
