Case Study: CH-1983

## NALCO CHAMPION HEAT OPTIMIZED MAINTENANCE COST AND IMPROVED RELIABILITY FOR PLANT

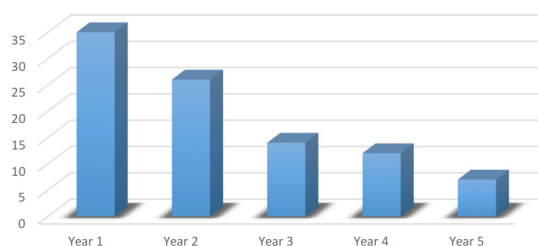
**Number of Cooling Water Heat Exchangers Cleaned Per Year**

The customer reliability department kept historical maintenance records for 67 exchangers. More than half of them were slated to be cleaned each year as a preventative measure, regardless if they were clean. After Nalco Champion HEAT was implemented, comprehensive performance data was provided to make data driven decisions on which heat exchangers should be cleaned.

As a result of the upgraded High Charge Polymer and improved heat exchanger monitoring, Nalco Champion was able to remove unnecessary cleanings from the Spring Cleaning list. By the 5<sup>th</sup> year of implementing HEAT, the cleaning costs had been reduced by 80%. *(The \$600,000 only represents the physical cleaning cost savings)*

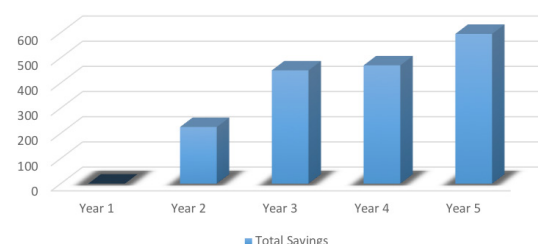
**Total Savings Achieved (in thousands of US dollars)**
